**TOWN OF SHADY SHORES  
PLANNING AND ZONING COMMISSION  
SPECIAL CALLED SESSION  
AUGUST 6, 2020; 7:00 PM  
VIRTUAL MEETING  
SHADY SHORES COMMUNITY CENTER  
101 S. SHADY SHORES ROAD  
SHADY SHORES, TX 76208**

**FINAL PLAT**  
**Lots 84-98, 1X, & 2X, Block A**  
**HIDDEN VALLEY AIRPARK, PHASE VI**  
**19.268 Acres**  
in the  
W.D DURHAM SURVEY, ABSTRACT NO. 330  
TOWN OF SHADY SHORES  
DENTON COUNTY, TEXAS

# Delineation of Waters of the United States

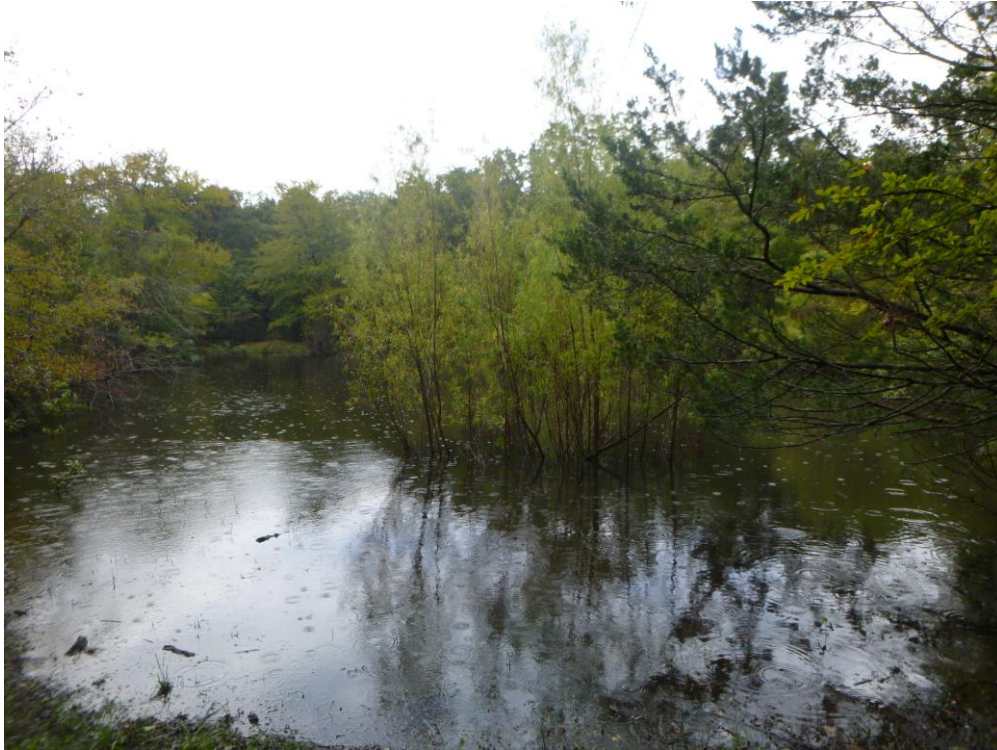
Photo 1: View, facing north, of Wetland 1 and Pond 1 located at T1P2.

Community Type A (**Table 1**) represents Wetland 1 and Wetland 2 located in the northwest portion of the study area. Wetland 1 and Wetland 2 appeared to be sustained by surrounding sheet flow. Wetland 1 and Wetland 2 appear to drain into Community C, down-gradient. Surface water conveyance with minor turbidity was observed during the time of the site reconnaissance. Wetland 1 was delineated to be approximately 0.160 ac in size and Wetland 2 was delineated to be approximately 0.003 ac in size.

Community Type D represents Pond 1 located in the northwest portion of the study area. Pond 1 appeared to be constructed out of an upland area. A berm/diked area was observed along the western edge. Pond 1 is sustained by surrounding sheet flow from the south and east and appears to not drain.

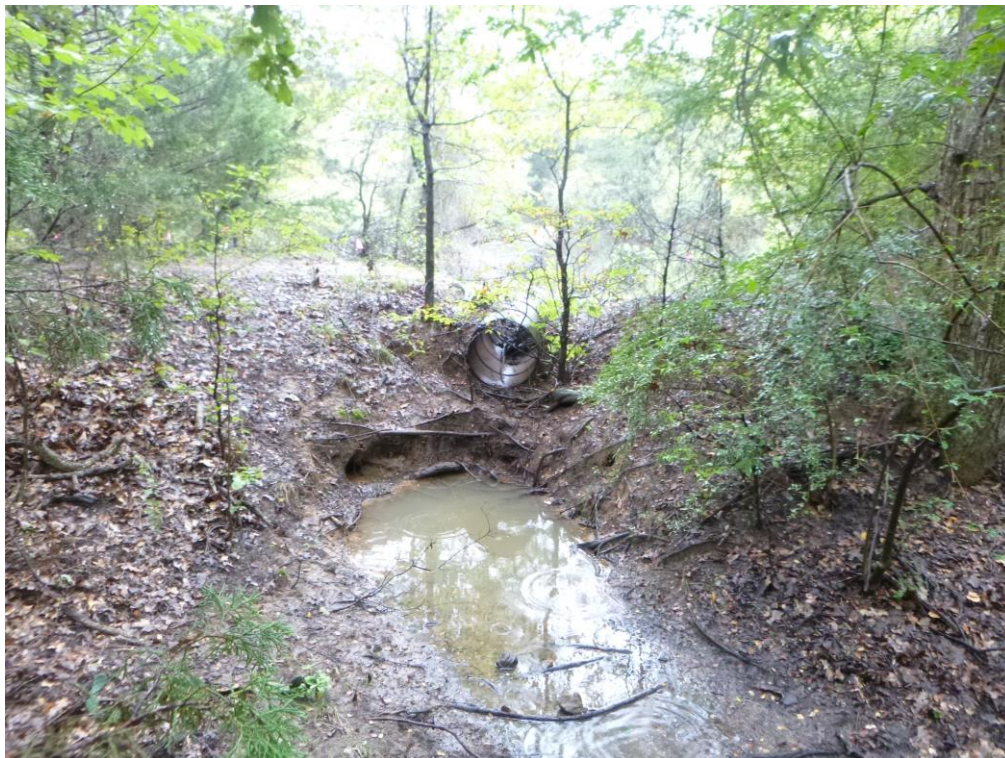
Photo 2: View, facing east, of the culvert and drainage swale located at T2P2.

Community Type C (**Table 2**) represents two drainage swales located in the northwest portion of the study area. The drainage swale community was classified as an upland area because the three wetland criteria were not all met. Surface water flow was observed during the field reconnaissance. Both drainage swales appeared to be connect to Wetland 1, one up-gradient and the other down-gradient.

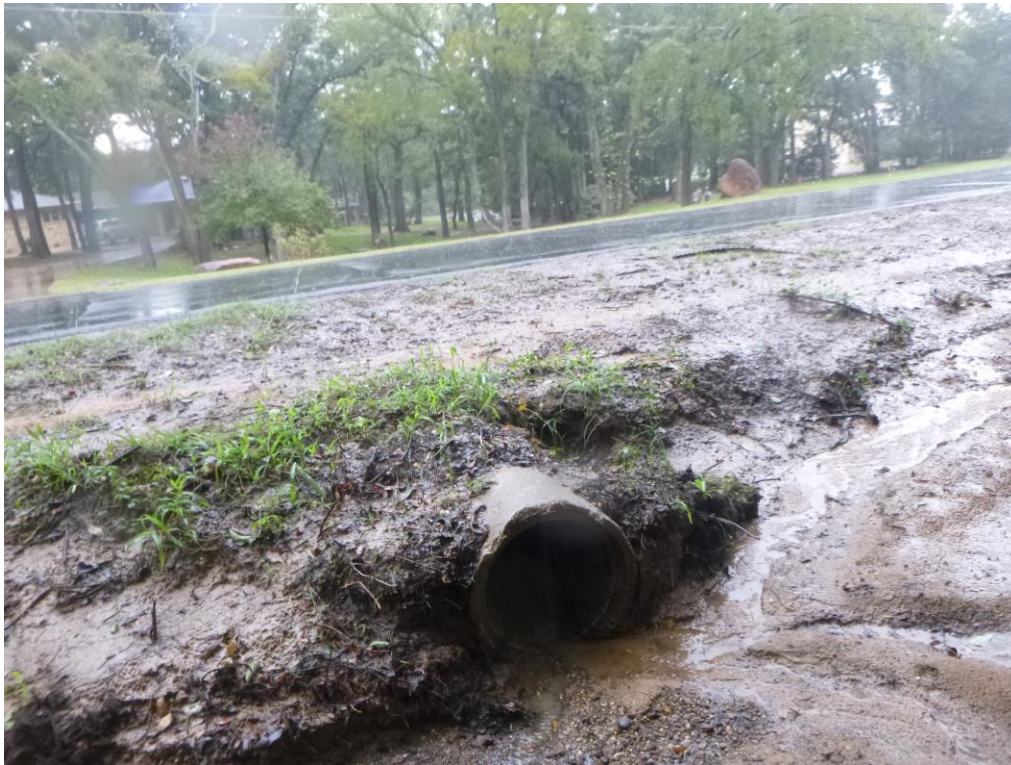
Photo 3: View, facing west, of the culvert that runs under Hidden Valley Road.

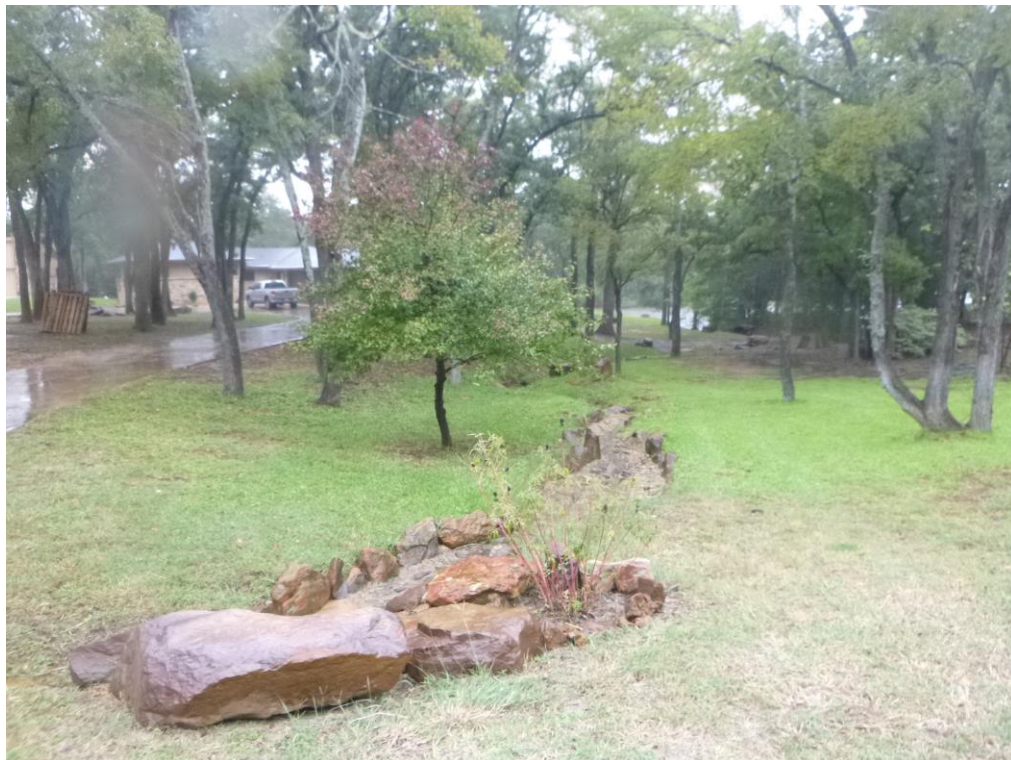
Photo 4: View, facing west, of the man-made drainage channel located on the western side of Hidden Valley Road.

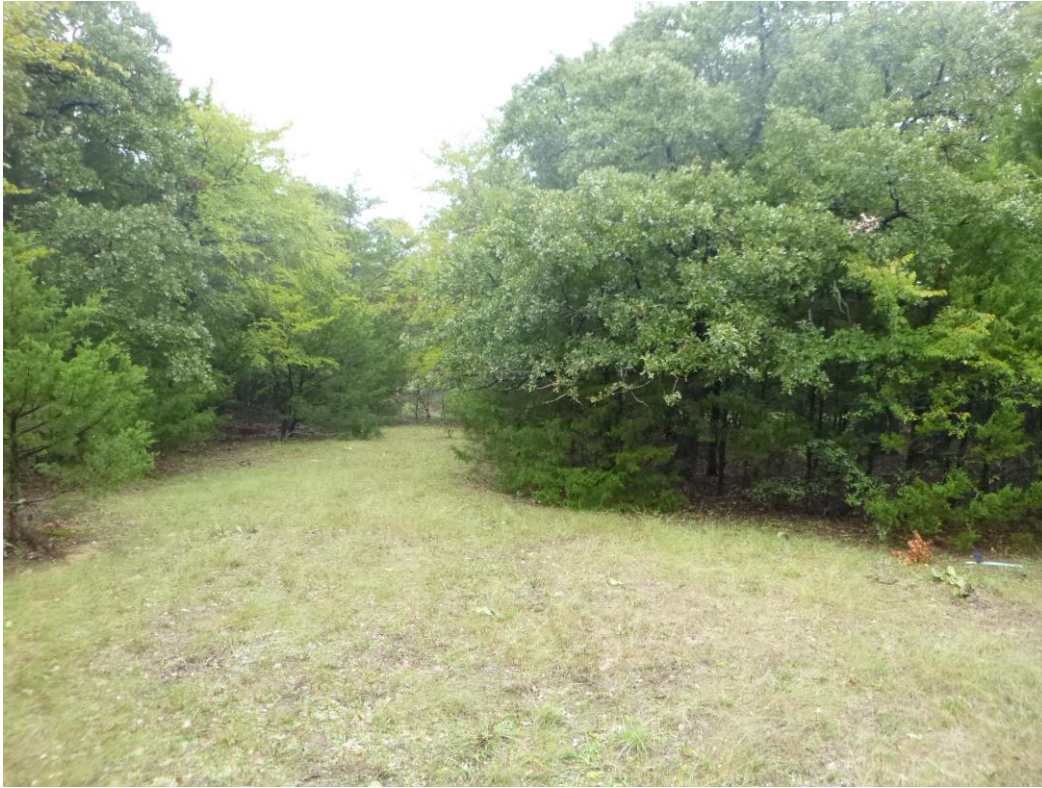
Photo 5: View, facing north, of the upland area located at T3P1.

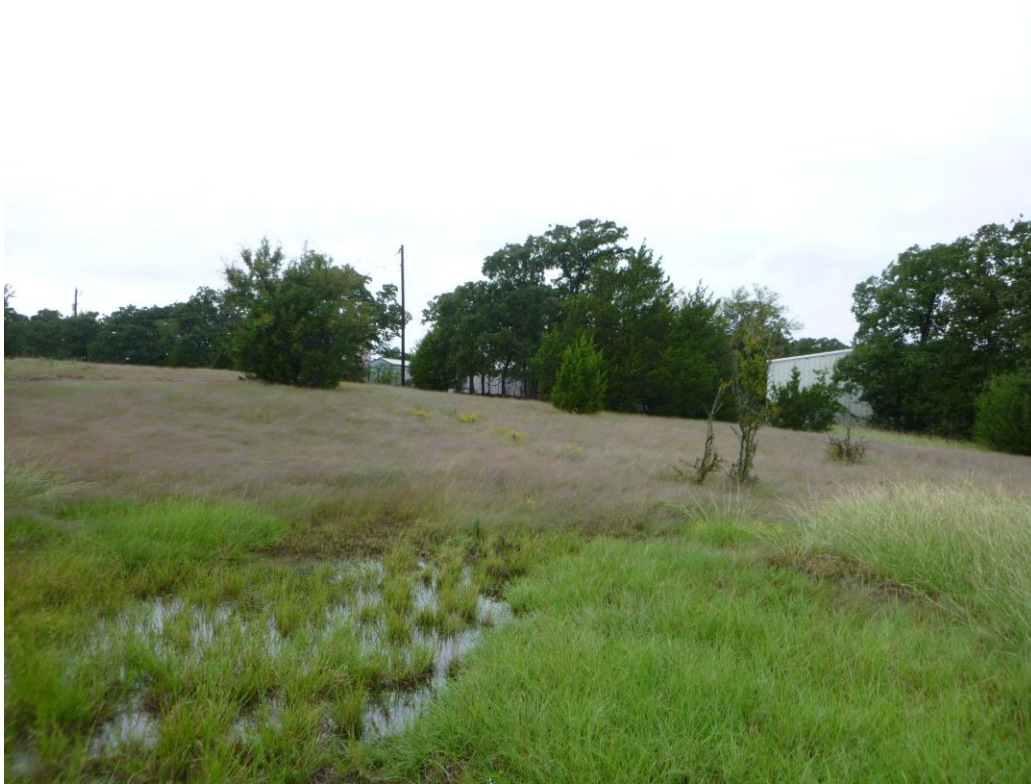
Photo 6: View, facing south, of a vegetated swale located at T4P1.

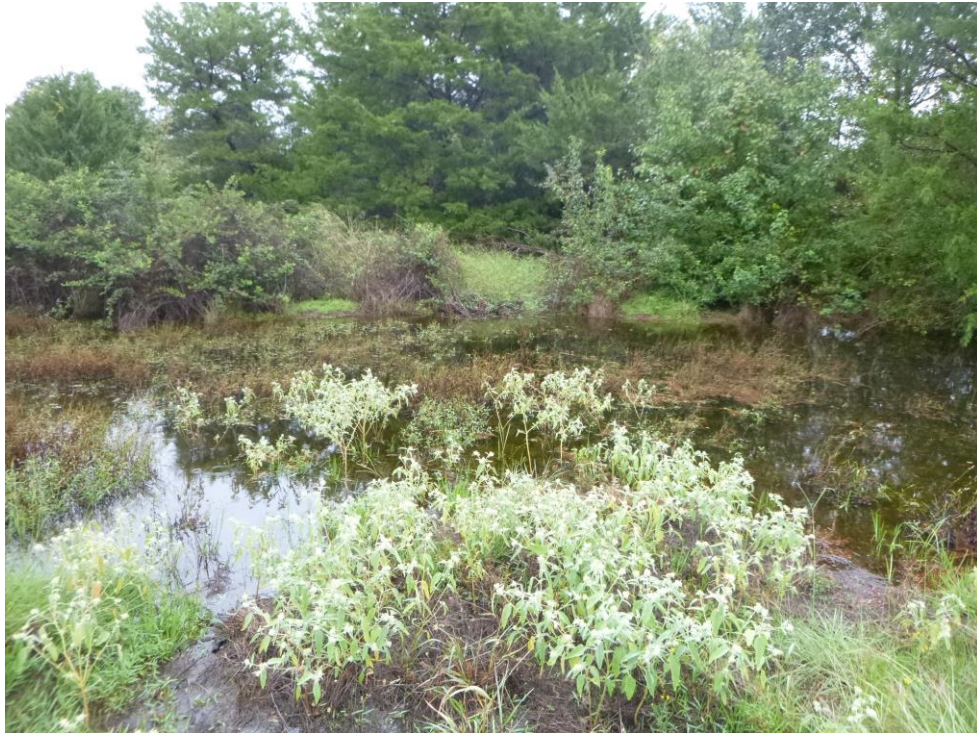
Photo 7: View, facing east, of Wetland 4 located at T5P1.

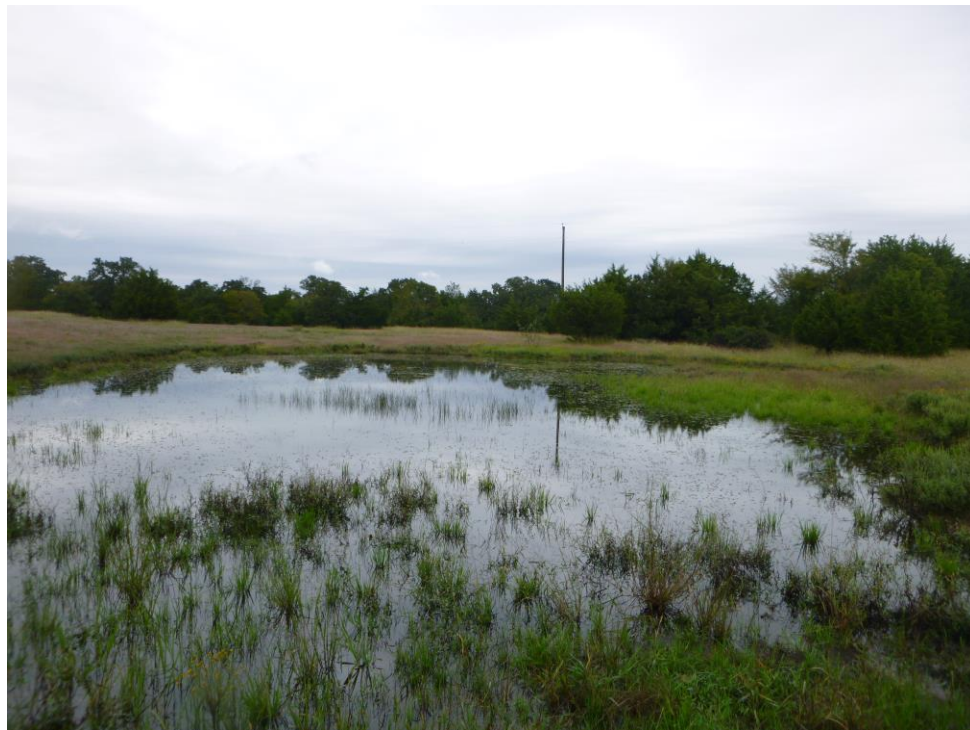
Photo 8: View, facing north, of Wetland 3 located at T6P3.

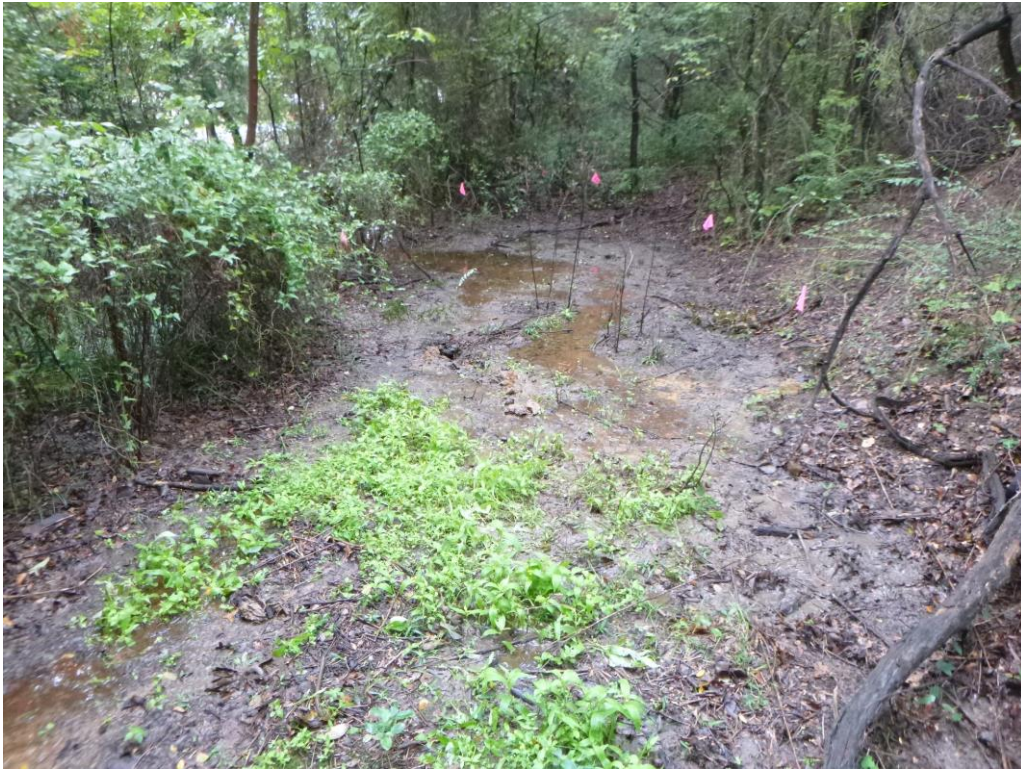
Photo 9: View, facing north, of Wetland 2 located at T7P2.
