**TOWN OF SHADY SHORES
BUILDING AND STANDARDS COMMISSION
MARCH 13, 2025; 6:00 PM
SHADY SHORES COMMUNITY CENTER
101 S. SHADY SHORES ROAD
SHADY SHORES, TX 76208**

Minimum Standards Report

N Garza Aka 120 N Garza.

Improvement #1 Commercial – 4 PLEX- 6 apartments

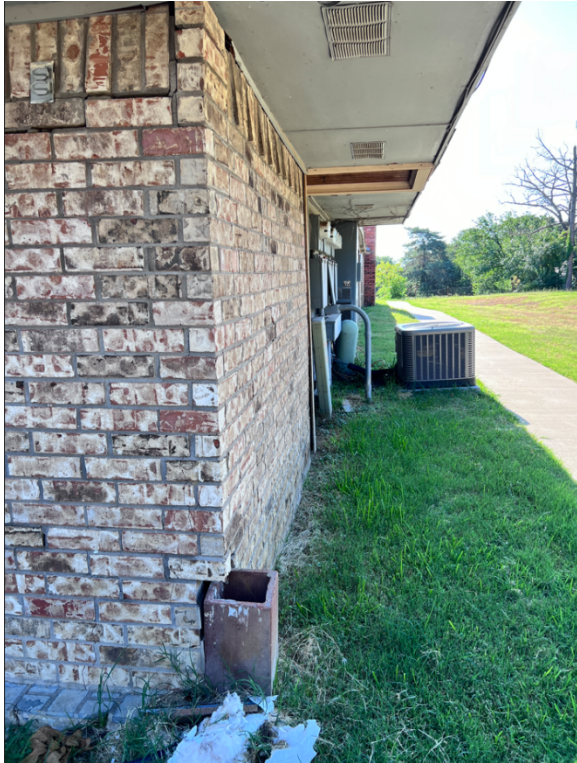
Date:6.25.24

Location: South Facing Wall,

Description: On 6.25.24, inspectors observed that meter box #2 was missing cover. Meter covers provide protection from the elements, prevent damage to internal components, and safeguard against potential electrical hazards caused by exposure to moisture or weather extremes.

This is a violation of NEC 312.102 (National Electrical Code)

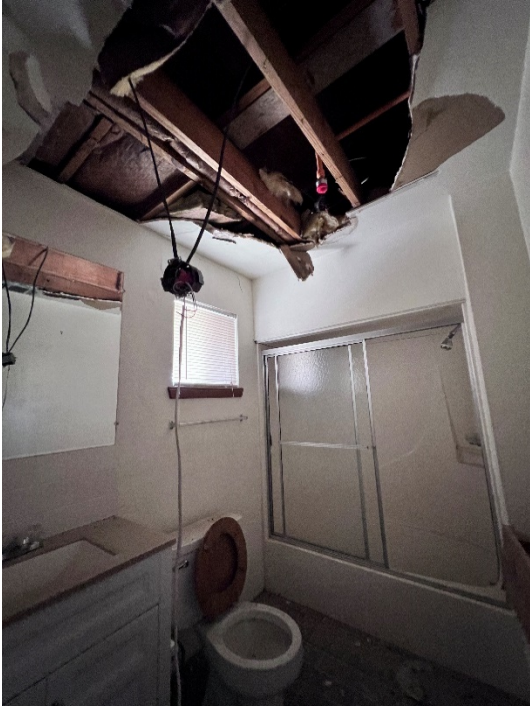
Location: Throughout the structure

Description: Electrical wiring throughout the structure has been left exposed and unprotected, increasing the risk of an electrical fire, shocks, and exposure to accidental contact.

This is a violation of IRC E3802.3

Photo of exposed wiring hanging from the ceiling in one of the bathrooms:

Owner shall repair or replace all damaged wiring, appliances, equipment, and service equipment to meet the standards set forth in the 2020 NEC

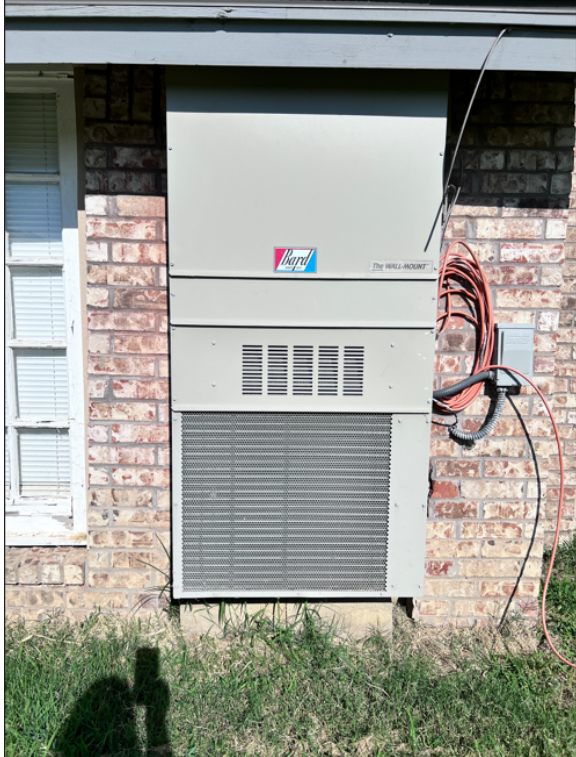
Location: AC Unit on South Side of Structure

Description: AC Unit- South Side does not have proper conduit covering over the electrical wiring, which can be damaged by the elements that may cause a short or electrical shock.

Violation of IRC 3802.3.2 and 3802.3.3

Photo of air conditioning unit on the south side with exposed wiring:

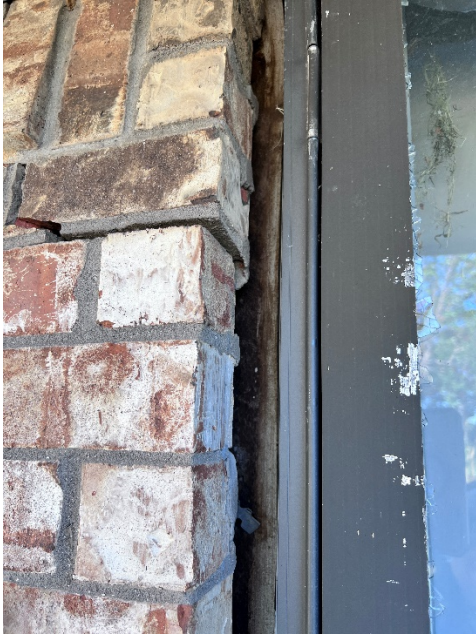
Location: Throughout the structure

Description: Multiple instances of the brick wall releasing from the structure so that the bricks on the wall may further shift and fall off or could be easily knocked from the structure, potentially causing large amounts of heavy brick material to fall.

Violation of IRC R606.13.2

Photo of brick buckling away from the wall near a window on the North side of the structure:

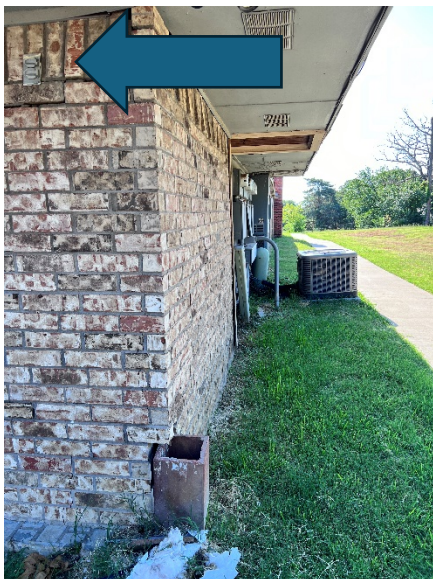
Location: West side of Structure near West side fireplace

Description: The electrical outlet encased in the soldier course/brickwork along the top of the structure poses a significant risk, as it may cause exposed electrical wires if the soldier coursing fails. This underscores the urgent need for immediate action to prevent potential hazards.

Violation of IRC R606.13.2

Photo of Brick is released from the wall, with an electrical outlet contained:

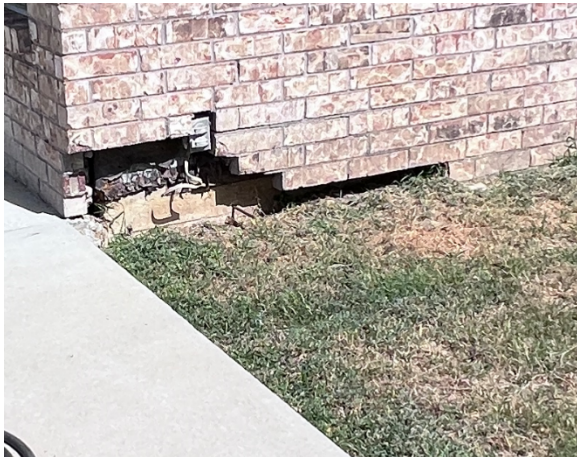
Location: West side of the building, North corner

Description: Electrical boxes on the ground are damaged, and exposed wiring is visible around the boxes.

Violation of NEC 210.52 E I

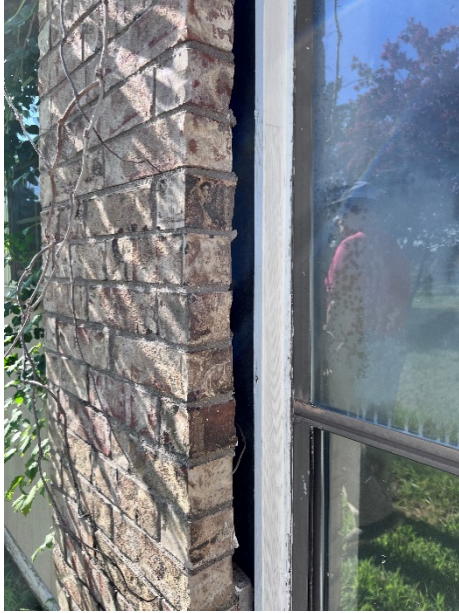
Description: Foundation- The owner stated that the foundation had been repaired with approximately 90 piers and had engineering approval. Evidence of a failed foundation is present. Walls have fallen outward away from the structure; Soldier Course/Brickwork along the top of the wall is falling into the structure, with significant cracking along various walls. No Town-issued permit or inspection documentation for foundation repair was found.

Violation IPMC 304.6

Photos: 1) Brick falling away from the wall next to the window.

Property owner shall provide documentation of foundation repairs designed by a licensed Engineer from the State of Texas and Geotechnical reports for the soil that support the Engineer's design for the repairs. The foundation repair shall meet all standards set forth in the 2021 IBC and the American Concrete Institute ACI 318.

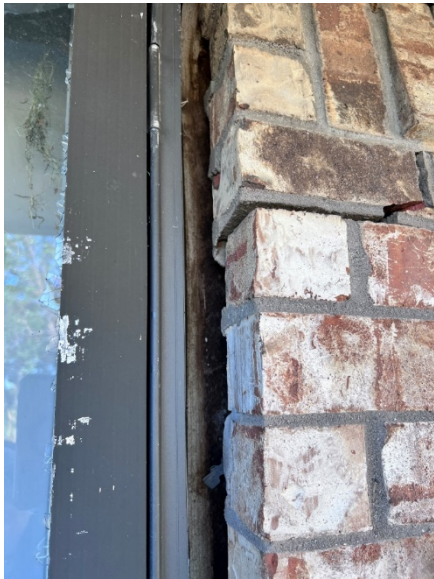
2. Brick falling away from structure around window

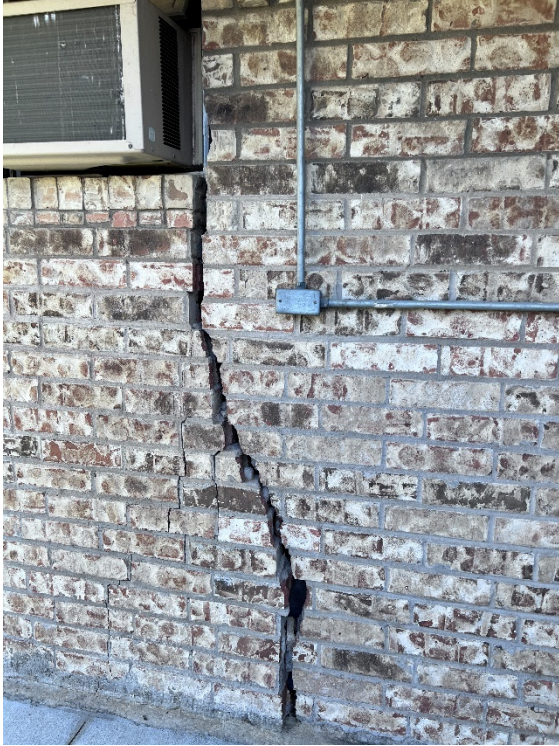
3. Large crack on East side – wide enough to fit a hand in vertically

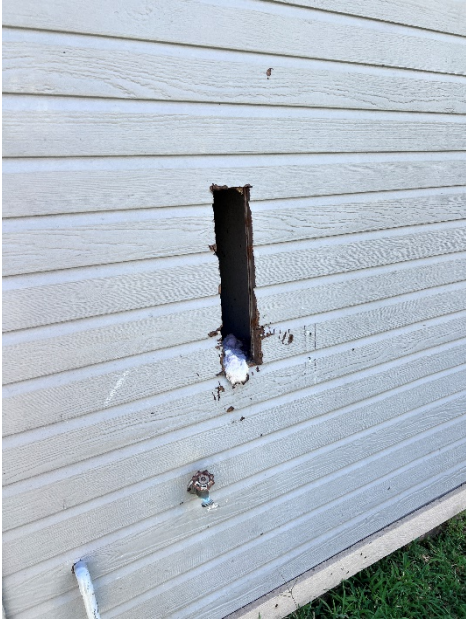
Description: Hole on the East side of the exterior wall

Violation of IPMC Section 304.06

- 1) Large hole on the east exterior wall, which allows access into the wall and the support for the wall.

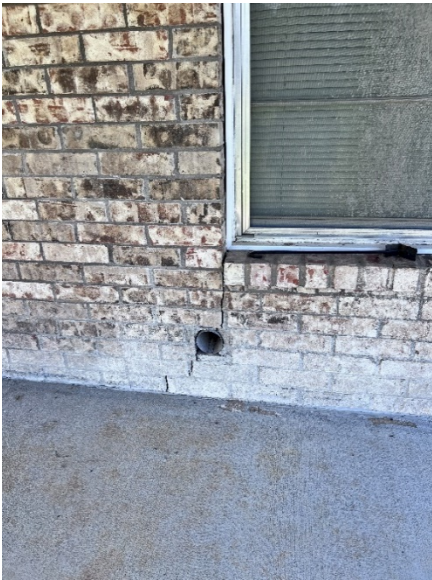
2: Unknown exposed open conduit into the building

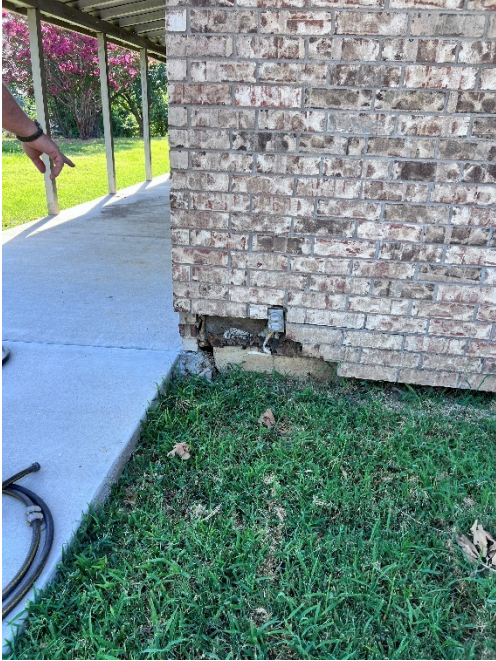
3. brick falling away from the structure, exposed wiring

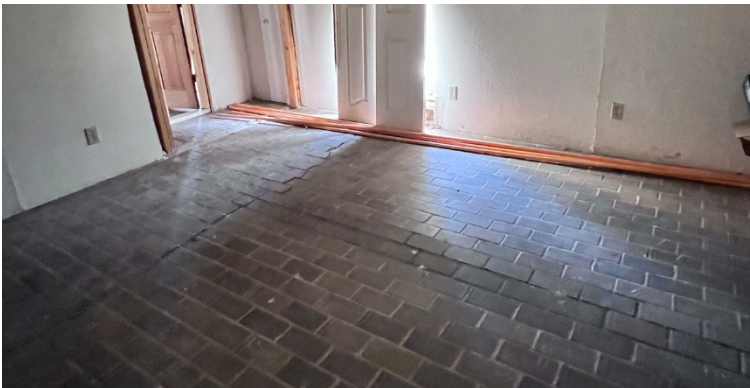
4. Inside of a unit showing the floor buckling and cracking

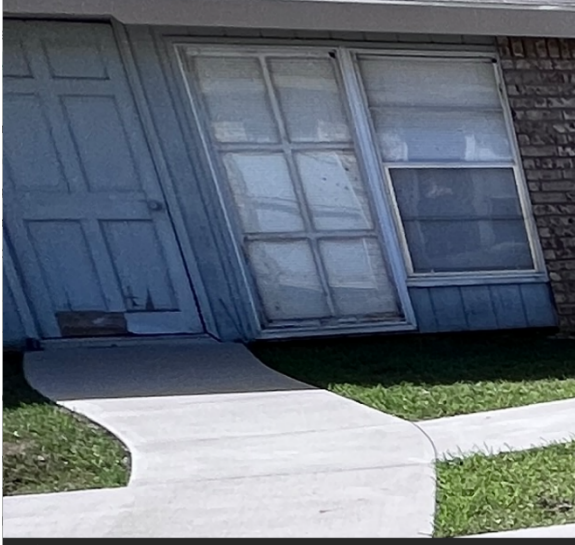
Description: Many areas on all sides of the structure are rotting and damaged, especially areas down low near the ground. Some damage has holes large enough for a small varmint to enter. Other areas are exposed to weather and wet conditions.

Violation IPMC 304.7

Photo of doorway and window to a unit -entering from the courtyard

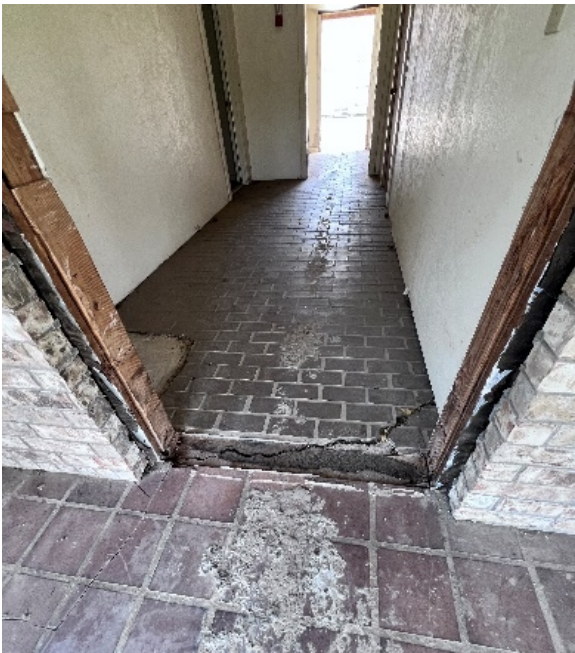
Description: Doors and doorways are missing or have significant damage, meaning the building or particular entries cannot be secured.

Photo of door missing from Exterior to the courtyard

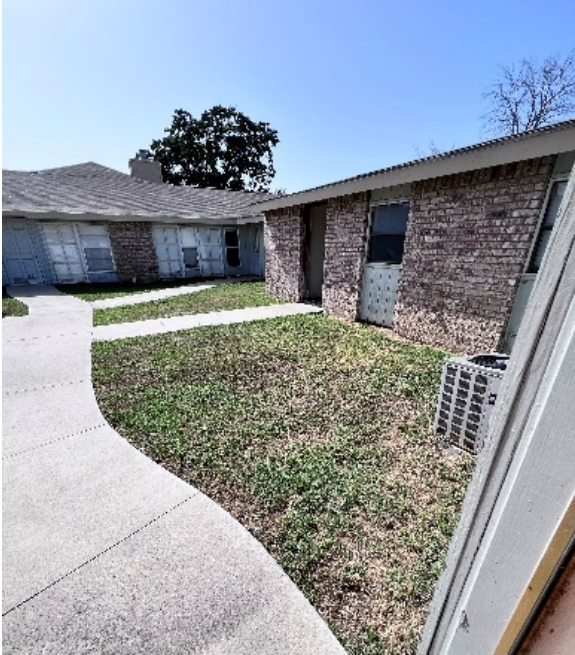
2. Courtyard doors showing damage

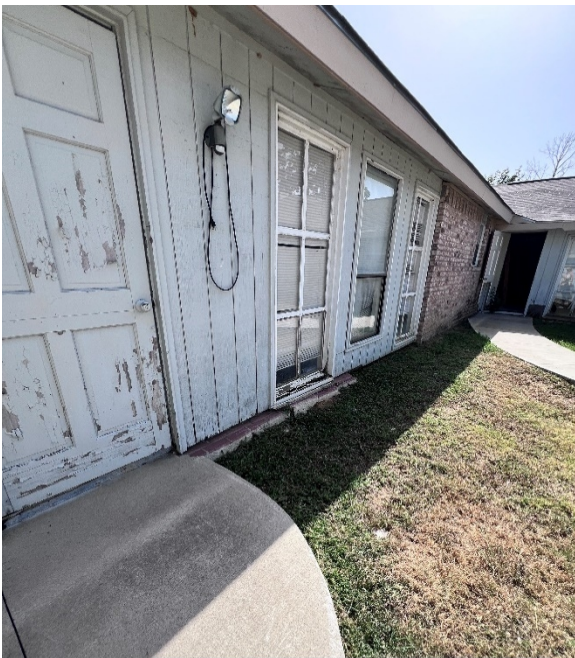
3. Doors and windows inside the courtyard showing damage

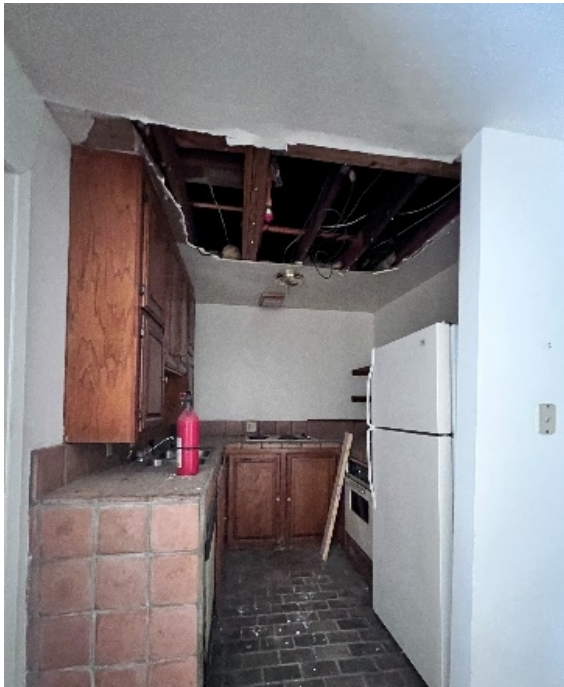
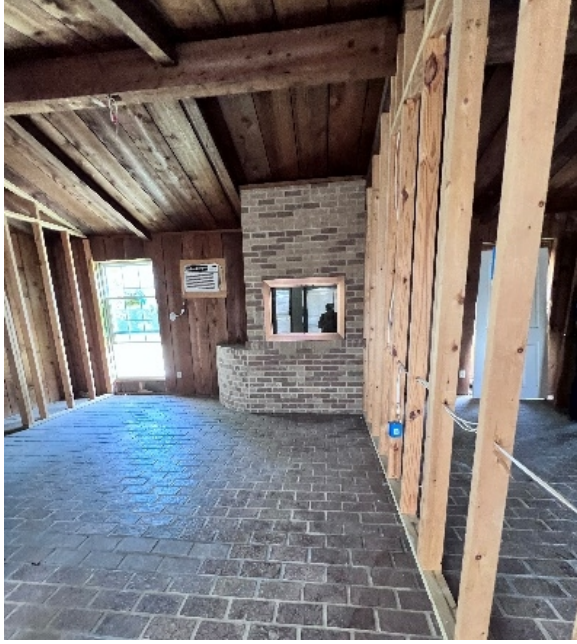
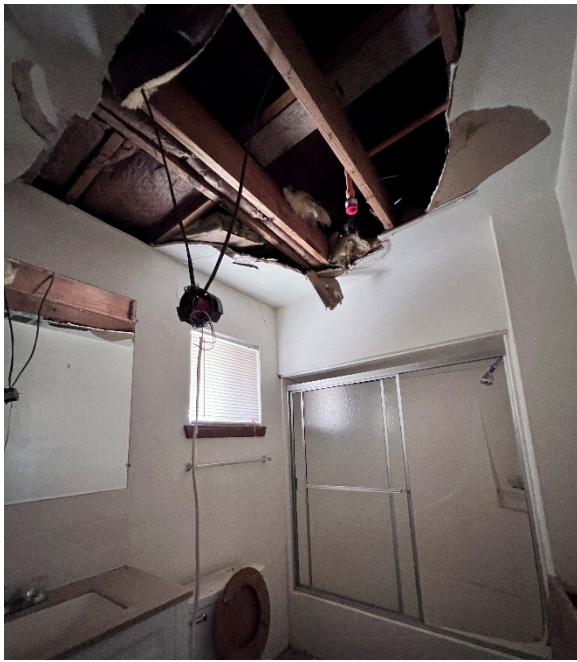
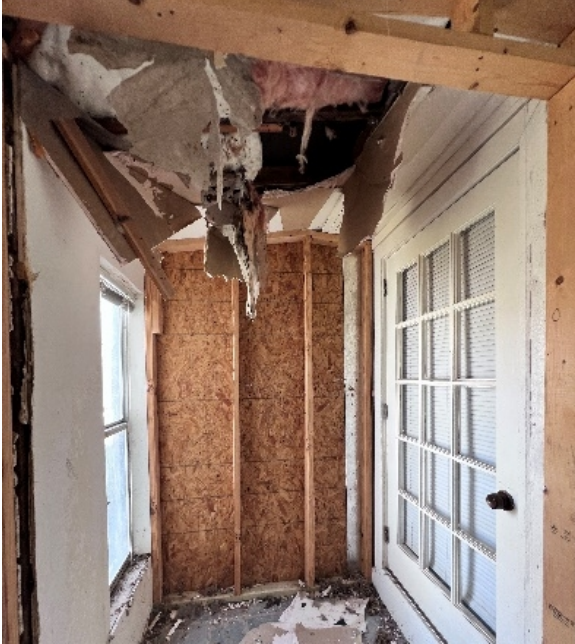
Description: Inside walls open and have exposed wiring.

Location: Various areas inside the unit

Description: The interiors do not have finished walls. Open framing was observed in all units. No units were habitable in their condition as observed on August 1 in that no units had completed walls and ceilings or plumbing, secured windows and doors.

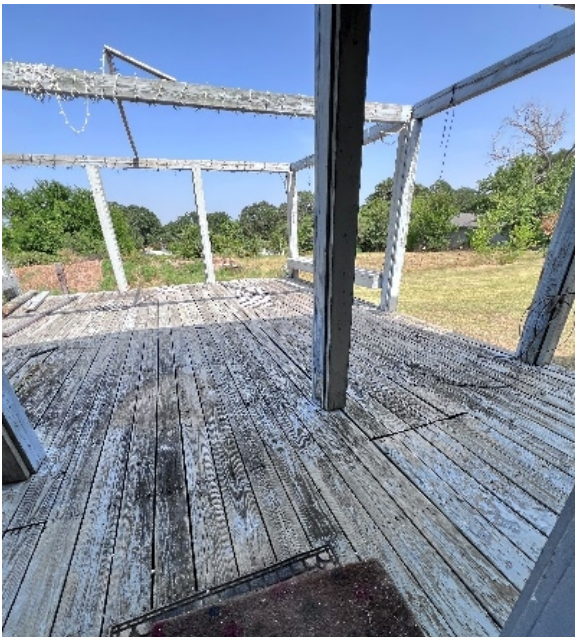
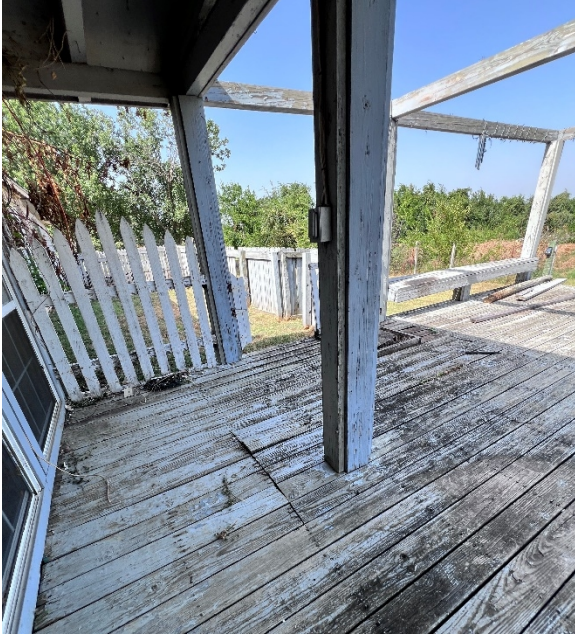
Location: Back of structure- east side of property

Description: Other structures, such as patio pergolas, are rotting and falling.

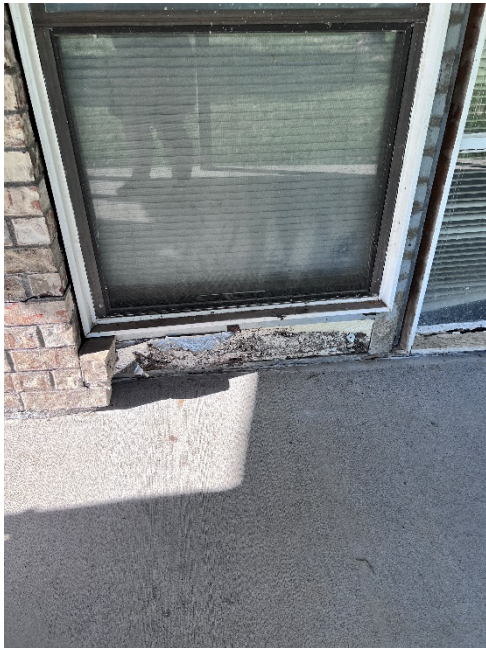
Description: Multiple window casings disjointed

Violation IPMC 111.1.5

The photo of the window casing is disjointed and missing brick covering

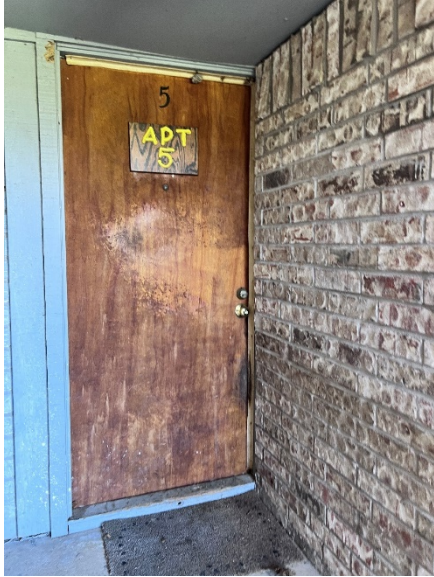
Location: North side of structure – Apartment 5

Description: An addition seems to have been added, and the wall partially covers the door jam. This means the egress is not clear for this doorway, which could cause injury to inhabitants.

Violation IPMC 702.1

Photo of apartment 5 door jam blocked by wall

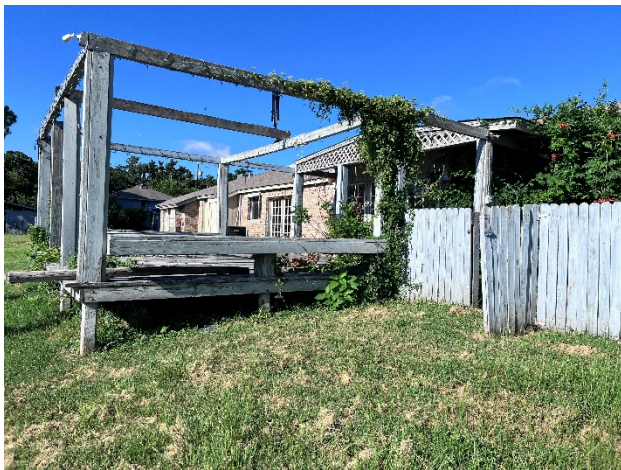
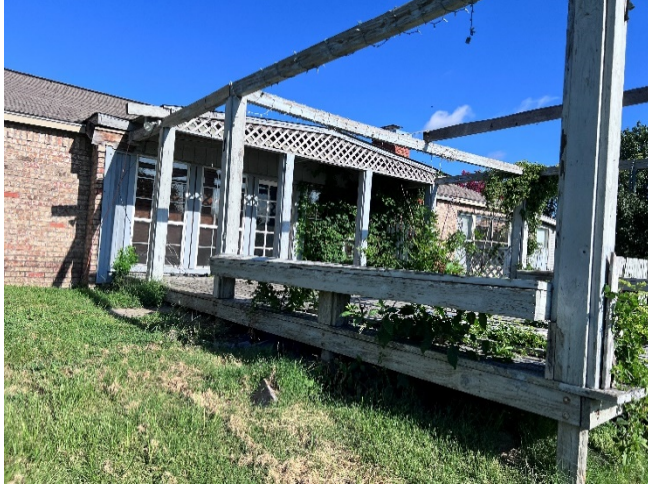
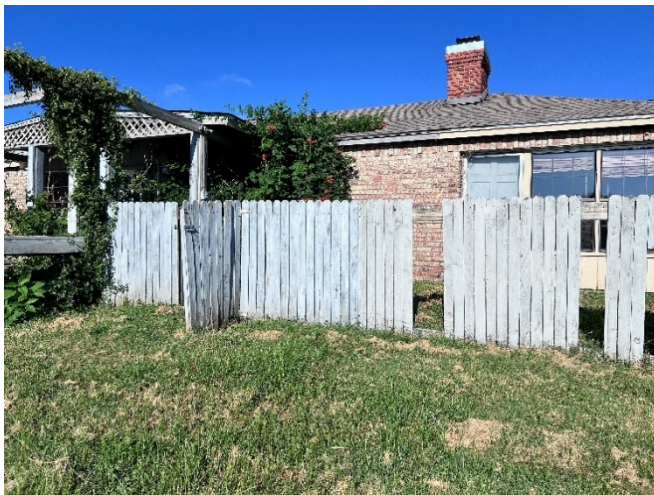
Description: The fencing is falling down and in disrepair.

Violation IPMC 304.2 and 304.10

Photo 1) Fence and deck on West side 2) looking east to deck 3) Fence on west side

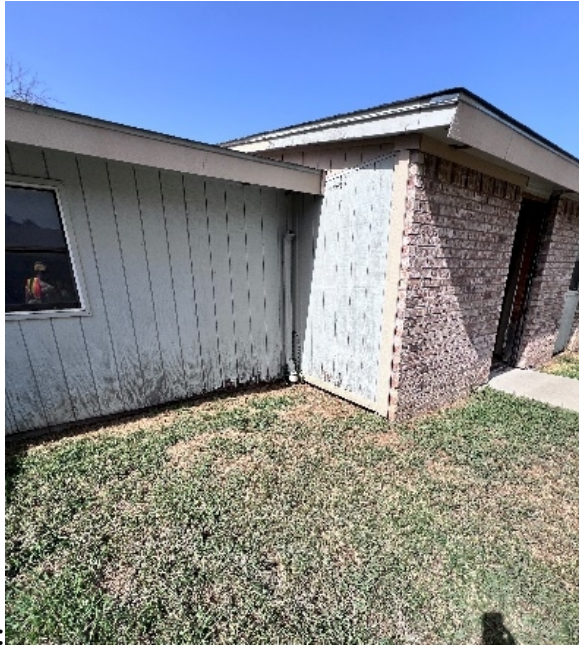
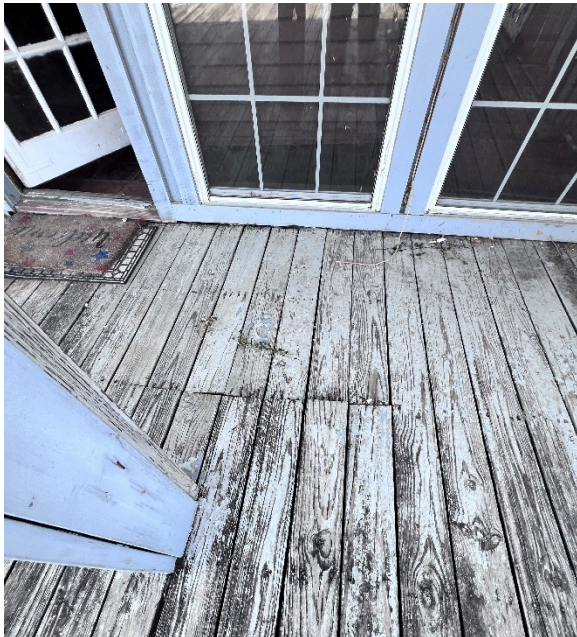
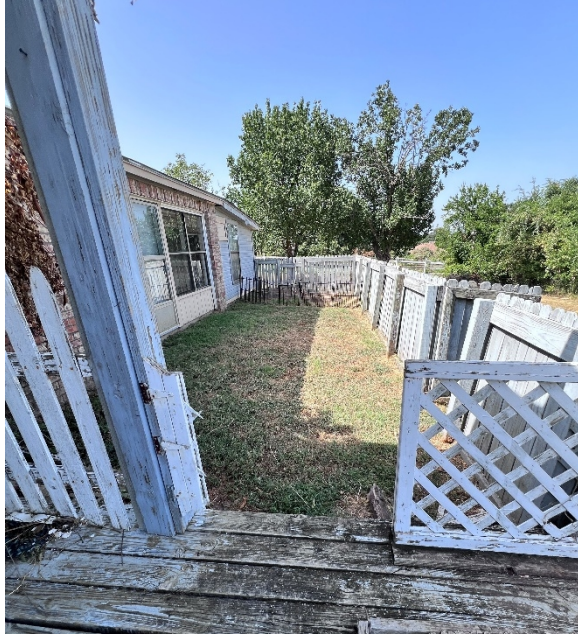
Description: Windows: Wood soffits, siding, and framing around most windows are rotting.

Violation IPMC Section 304

1. Wood siding rotting along the bottom edge

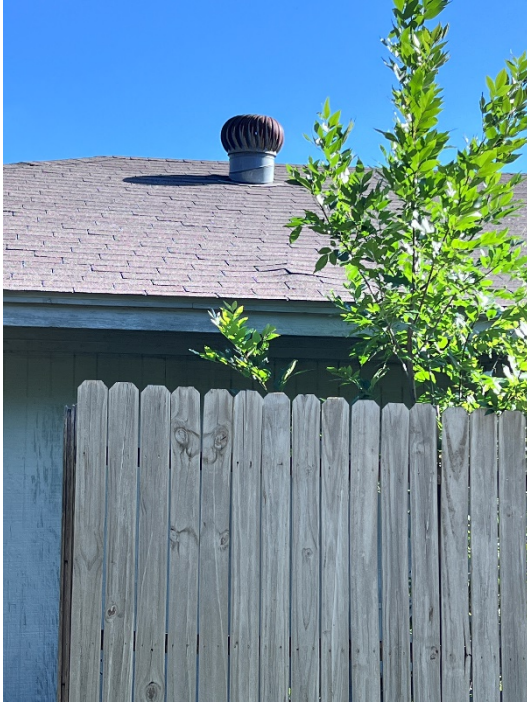
Location: standing looking north at the roof from the south side of the building

Violation IPMC 304.7

Description: Broken rafter in roof

Photo: The roof shows signs of at least one broken rafter, looking North from South, that can no longer support the roof.

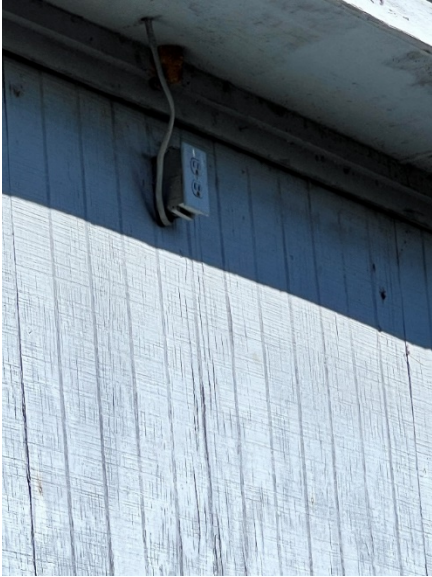
Location: East Eave outlet is located under eave.

Description: Unprotected wiring under East Eave

Violation IPMC 604.3

Photo of exposed wiring under eve, east side of building

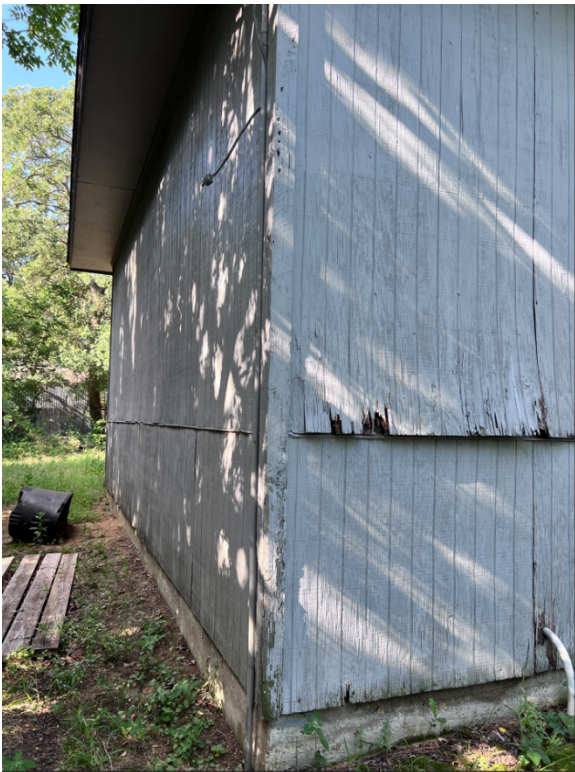
2. Garage: The garage seems to be on the same electrical meter as a wood structure.

Electrical conduit and plug- on the east side- may lead to the area behind trees. The cord seems to run underground.

Violation IPMC 604.1

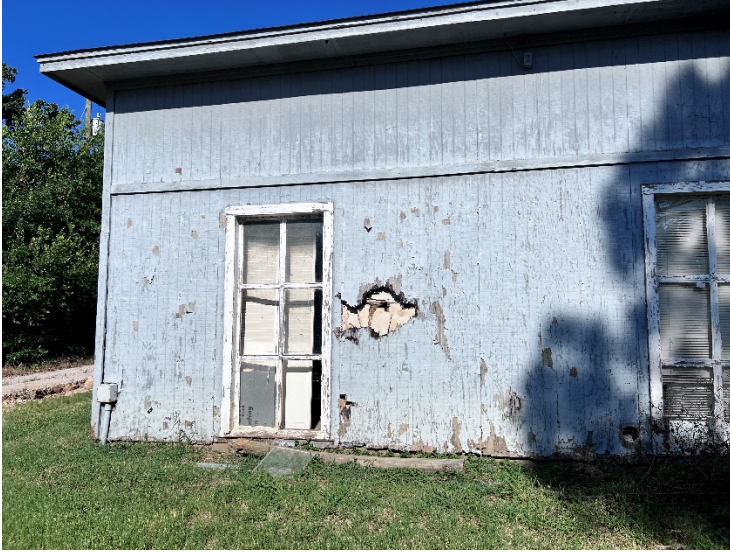
Location: West-facing exterior wall of the structure.

Description: There is an open hole in the garage wall that appears to allow access to the interior of the wall structure for vermin and weather.

Violation of the IPMC Section 304

Photo of a large hole in the west side of the building

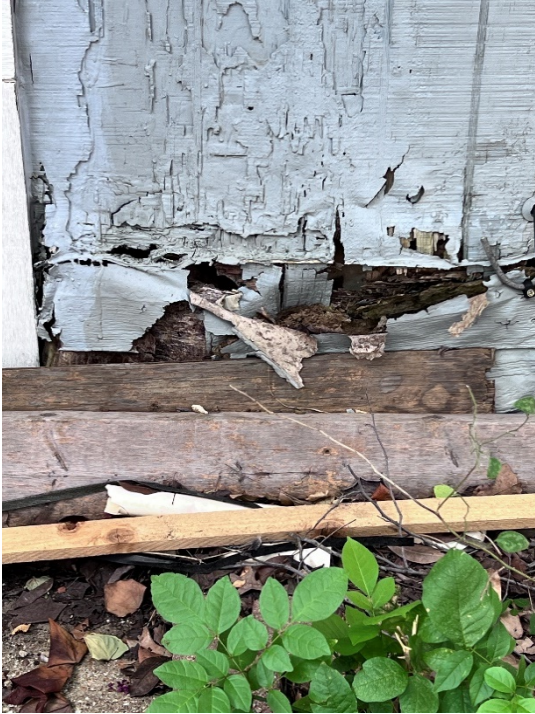
Description: Multiple holes were found around apartment units in the walls and structures that should have been otherwise enclosed. This allowed vermin and weather to enter, damage the structure, and potentially injure the health of occupants.

Violation of the IPMC 304.

- 1) Rot and holes along the foundation and wall Northside

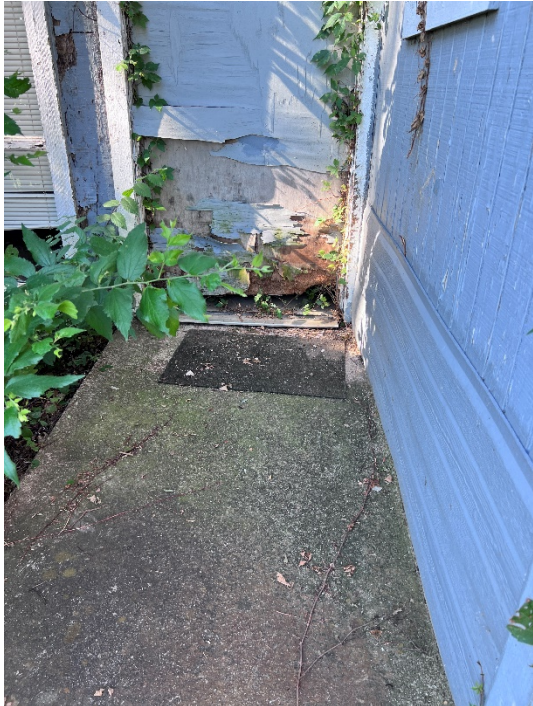
2) Holes in the doorway of units
